Project report

Group 3

This report developed as part of the Summerschool BikeAccess project in Ljubljana, where four international groups participated, aims to assess the current condition of the city's bike paths with a focus on accessibility for vulnerable groups such as people with disabilities, children and the elderly. The third group of the Summerschool BikeAccess project is composed of dedicated students from various countries, each bringing unique expertise in spatial planning. Ivona Nančeska from Macedonia, representing the team of Slovenia, is a second-year student at the Faculty of Civil and Geodetic Engineering in Ljubljana. From Poland, Cyprian Gubernat and Weronika Rdest, both fourth-year students of Spatial Development at the University of Economics in Krakow, contribute their knowledge of urban design and mobility systems. Mina Cvetković and Nadja Ugrinović, third-year students from Serbia, studying at the Faculty of Geography, Department of Spatial Planning in Belgrade, further enhance the teams's collective expertise in spatial analysis and sustainable development. This analysis will identify existing limitations in the cycling infrastructure and explore solutio

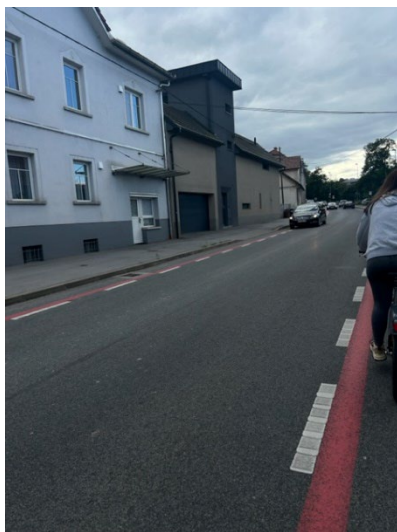
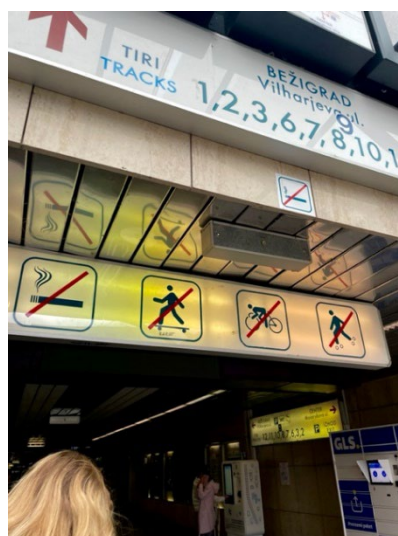
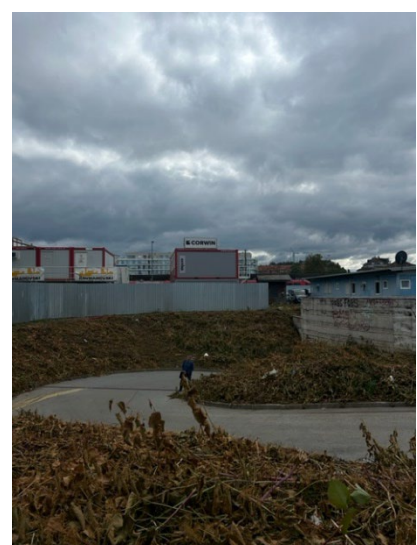
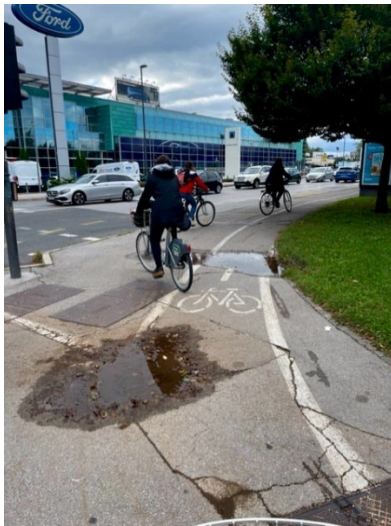
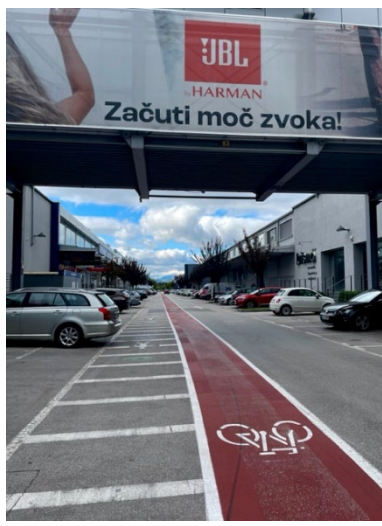
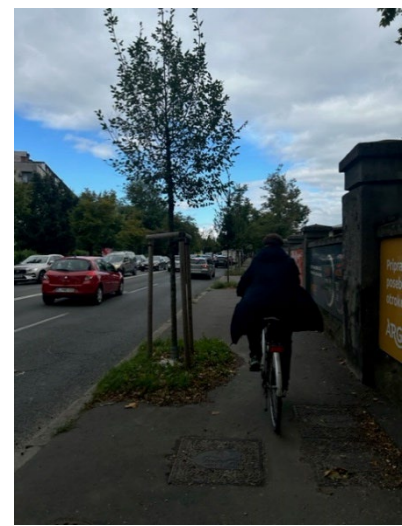
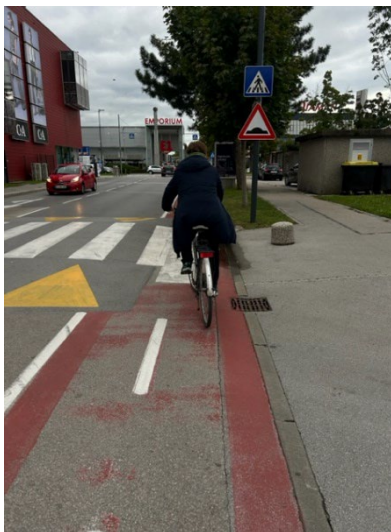
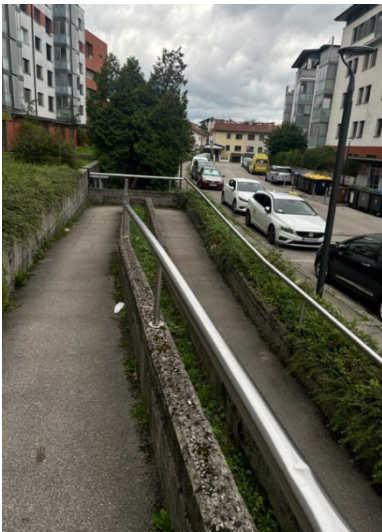
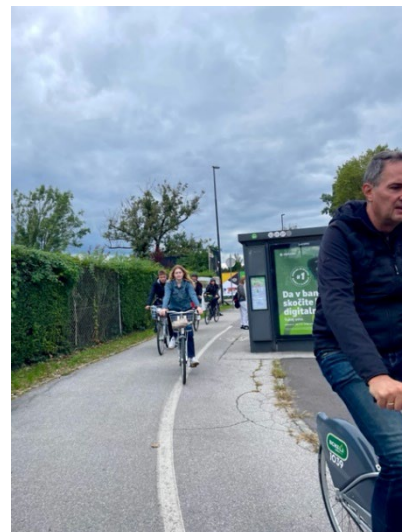
- **Bumps and Holes:** Throughout the city, we observed numerous bumps and holes on bike paths. These irregularities create an uneven surface that can be challenging for all cyclists, particularly for those with disabilities, the elderly, and children. The risk of accidents or bike damage increases significantly due to these conditions.

- **No Ramps at Crosswalks:** The absence of ramps at crosswalks presents a significant obstacle for cyclists, especially those with disabilities or carrying heavy loads. Without ramps, cyclists are forced to navigate curbs and uneven surfaces, which can be both unsafe and inconvenient.

- **No Shade:** Many bike paths lack shade, making cycling uncomfortable during hot weather. The absence of shaded areas can deter people from using the bike paths and can lead to heat-related issues for cyclists.

- **Few Resting Areas:** The scarcity of resting areas, such as benches and water fountains, along bike routes limits the opportunities for cyclists to take breaks and stay hydrated. This lack of amenities can make longer rides more strenuous and less appealing.

- **Narrow Paths:** narrow width of some bike paths restricts movement and makes it difficult for cyclists to pass each other comfortably. This can lead to congestion and safety concerns, particularly on busy routes.

- **No Adaptive Bikes:** The absence of adaptive bike options along the bike paths means that cyclists with disabilities have limited opportunities to use the infrastructure effectively. This lack of provision excludes a significant portion of the population from fully benefiting from the bike path network.

At the train station, we recommend installing a wide elevator to accommodate bikes and wheelchairs, and expanding the ramp inside the station to ensure ease of access. Additionally, clear signage throughout the city should be implemented to guide cyclists effectively.

Along the bike route, we suggest narrowing car lanes and widening bike paths and walkways to provide more space for cyclists. Installing fences near construction sites and launching a social campaign with posters at bus stops can help raise awareness about vulnerable groups. We recommend increasing the number of resting areas with benches and water fountains along the bike paths. Implementing sound signalization at every crossing will improve safety, while cohesive signage or painted bike paths will help cyclists navigate the route more easily. Removing obstacles such as signs and bus stops, repairing holes and uneven surfaces, constructing a bicycle-pedestrian bridge above the train tracks, and creating a new parking area at the start of Smartinska Street are also crucial improvements.

At the shopping center, reducing parking spots to create two-way bike paths and renovating the wheelchair ramp to ensure it is accessible for bikes will further enhance the cycling infrastructure and overall accessibility.
